Applies To: **2003 Accord L4 A/T – ALL**

2004 Accord L4 A/T 2-door – From VIN 1HGCM7...4A000001 thru 1HGCM7...4A009608

2004 Accord L4 A/T 4-door – From VIN 1HGCM5...4A000001 thru 1HGCM5...4A057899

Engine Vibrates While Idling In Gear

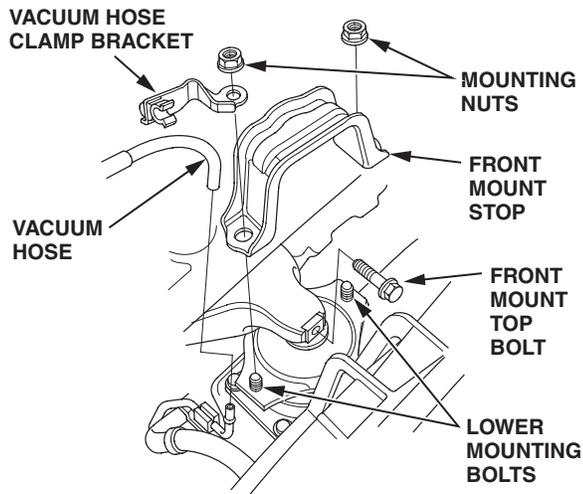
Excessive vibration is felt in the seat and steering wheel when the transmission is put in Drive or Reverse. The vibration may be worse in cold weather or with loads, such as with the A/C on or when the steering wheel is turned.

Not enough engine dampening.

- Remove the front mount stop mounting nuts, the front mount stop, and the vacuum hose clamp bracket. Then remove the front mount bolt, and the four lower mounting bolts.

- Place a floor jack with a block of wood under the transmission, and raise the engine up enough to remove the front engine mount.
- Install the new front engine mount, and torque the four lower bolts to 54 N·m (40 lb-ft). Install the front mount stop and the vacuum hose clamp bracket, and torque the nuts to 78 N·m (58 lb-ft). Install the front mount bolt, but leave it loose at this time.
- Inspect the rear engine mount for tears, and replace it if necessary.
- With the vehicle on a lift, inspect the rubber exhaust mount for tears, and replace it if necessary.
